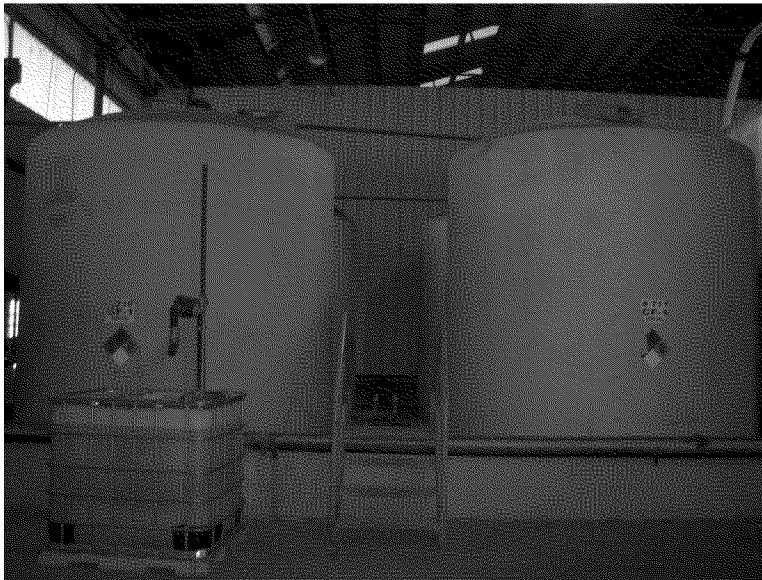
Photo # 2

Description: CF-1 Tanks and a tote inside plant building (IMGP0850)

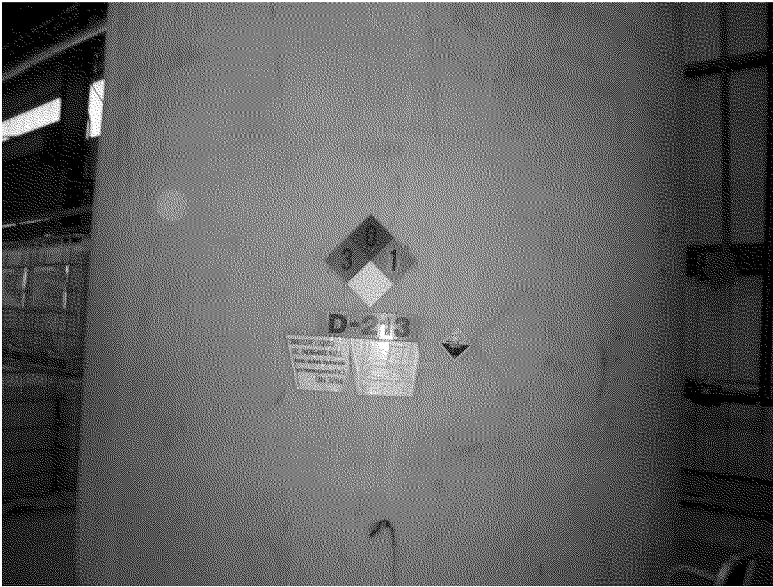
Photo# 3

Description: Sodium hydroxide tank inside plant building (IMGP0851)

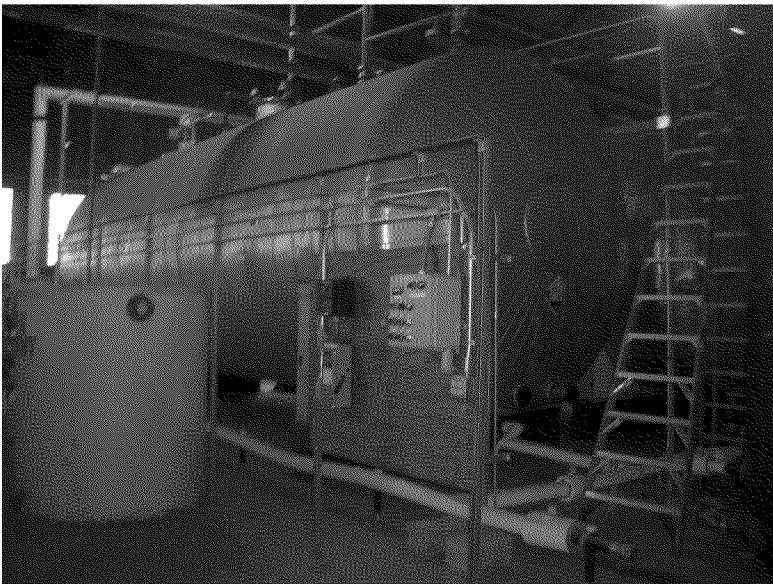
Photo# 4

Description: Tanks and piping inside plant building (IMGP0852)

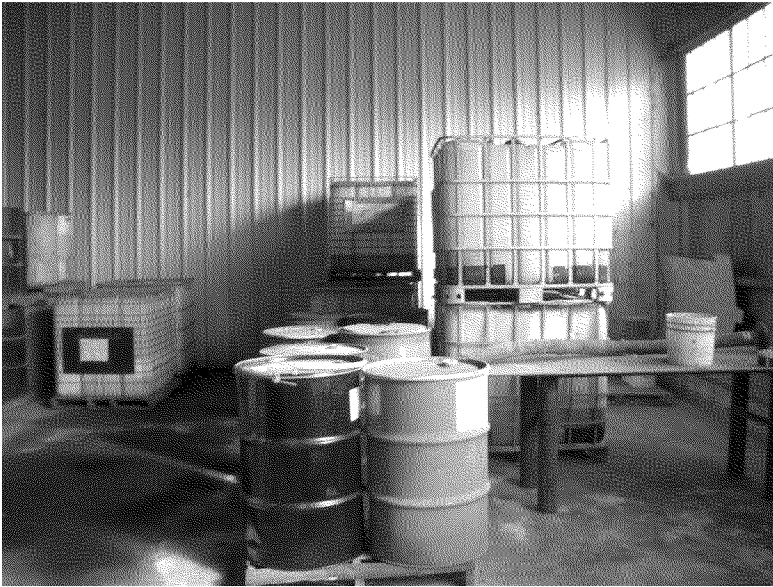
Photo# 5
Date: 11/3/09
Time: 0943
Description: Drum and tote storage area (IMGP0853)
Photographer: M. Moloney

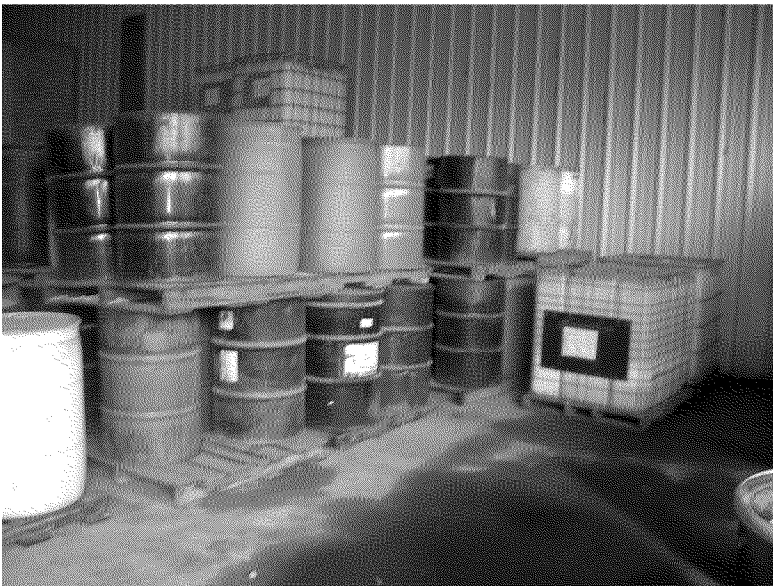
Photo# 6
Date: 11/3/09
Time: 0944
Description: Drum and tote storage area (IMGP0854)
Photographer: M. Moloney

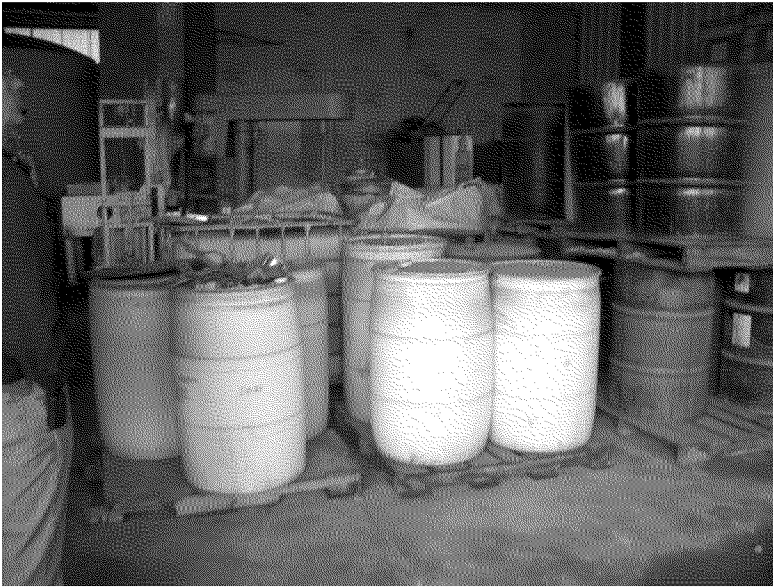
Photo# 7
Date: 11/3/09
Time: 0944
Description: Drum and tote storage area (IMGP0855)
Photographer: M. Moloney

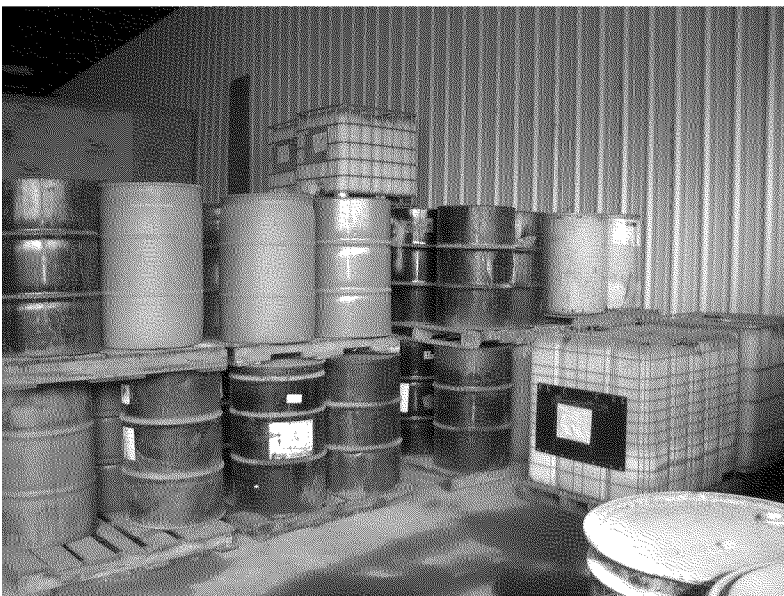
Photo# 8
Date: 11/3/09
Time: 0944
Description: Drum and tote storage area (IMGP0856)
Photographer: M. Moloney

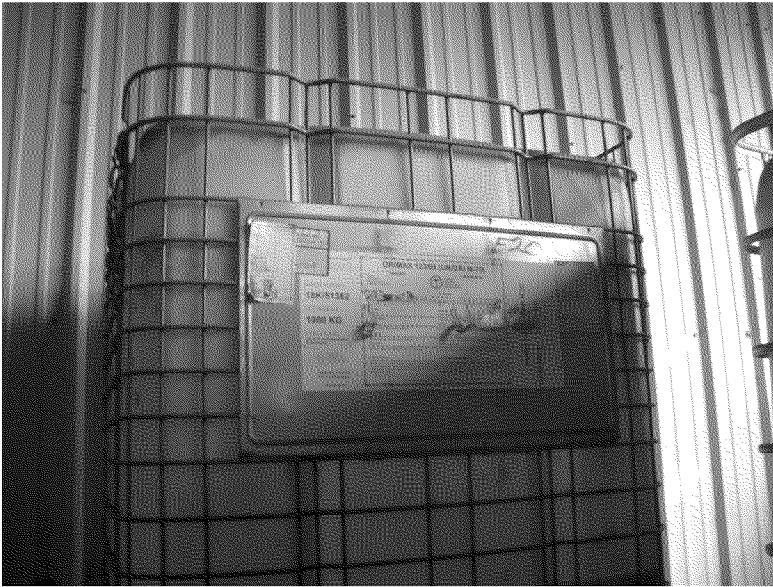
Photo# 9

Description: Tote labeled "DRIMAX 1235B" (IMGP0857)

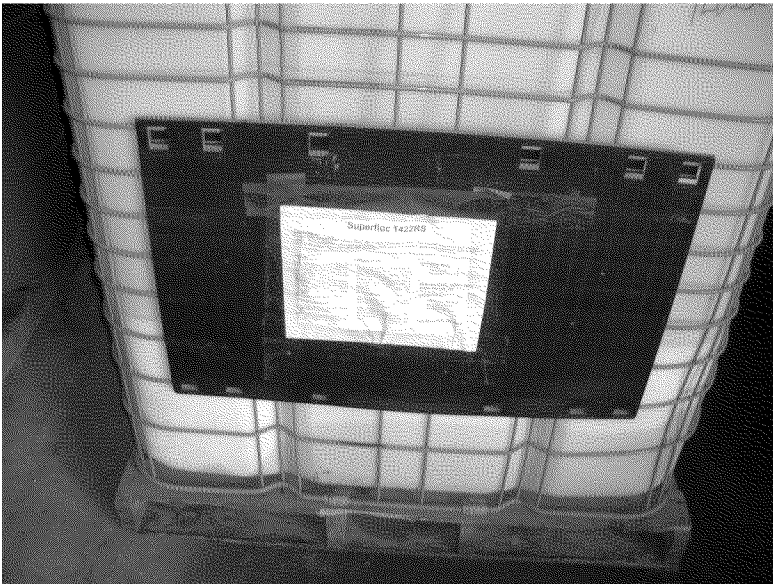
Photo# 10

Description: Tote labeled "Superfloc 1422RS" (IMGP0858)

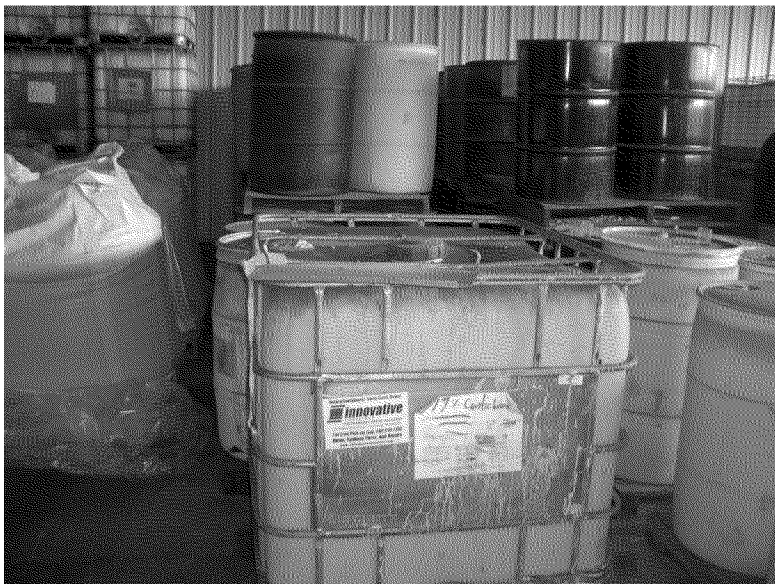
Photo# 11

Description: Tote with "17% caustic" written on label (IMGP0859)

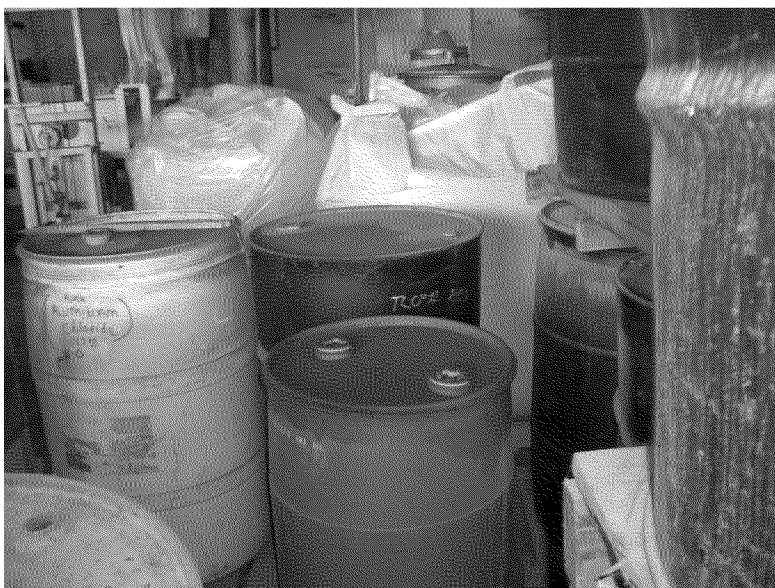
Photo# 12

Description: Drums in storage area with written descriptions that include: "pure aluminum chloride 27%" and "TCLP #..." (IMGP0860)

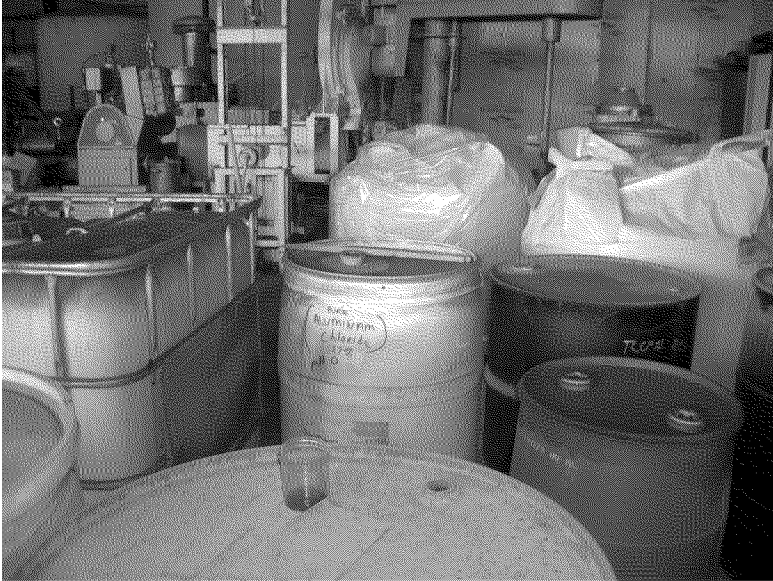
Photo# 13

Description: Drums, totes and super sacks (IMGP0861)

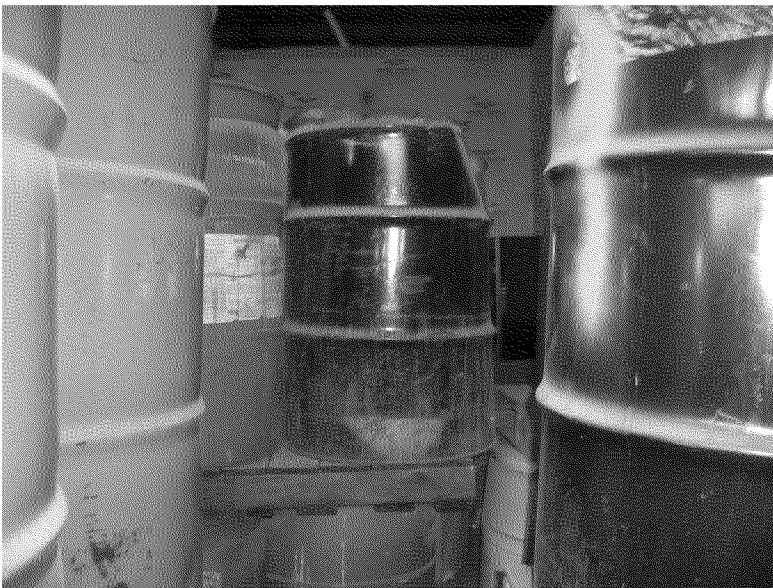
Photo# 14

Description: Corroded drum in storage area (IMGP0862)

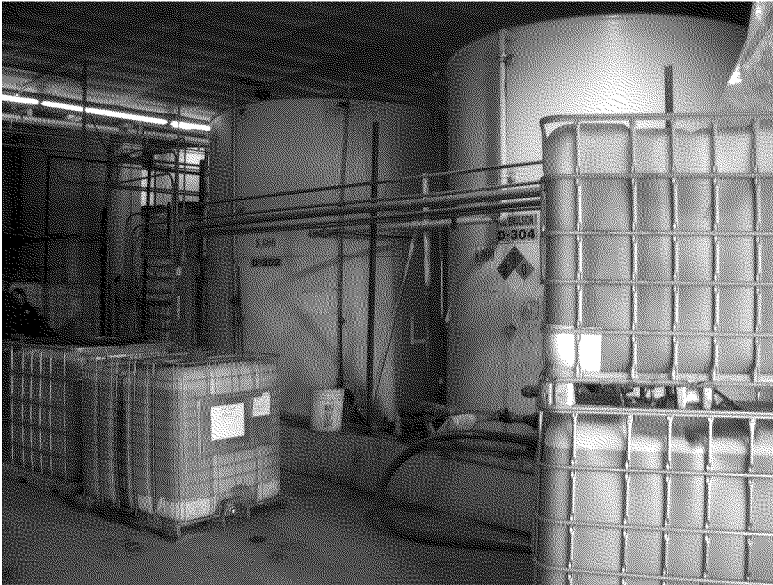
Photo# 23

Description: Tanks Nos. D-302 & D304 labeled "Oil Emulsion", "8000" (IMGP0871)

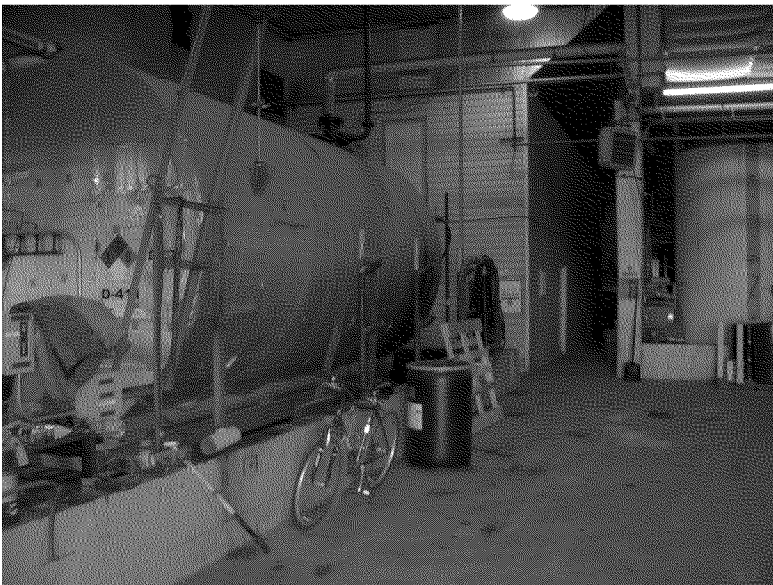
Photo# 24

Description: Tank inside dike (IMGP0872)

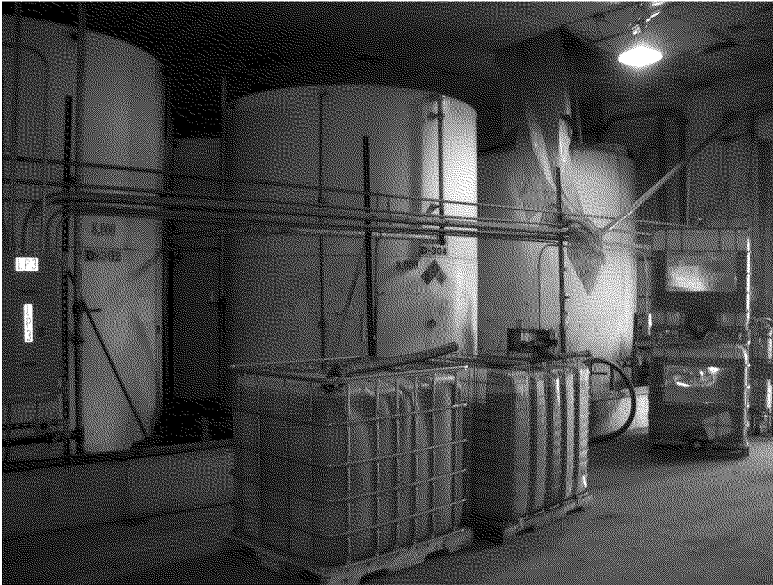
Photo# 25

Description: Tank inside dike (IMGP0872)

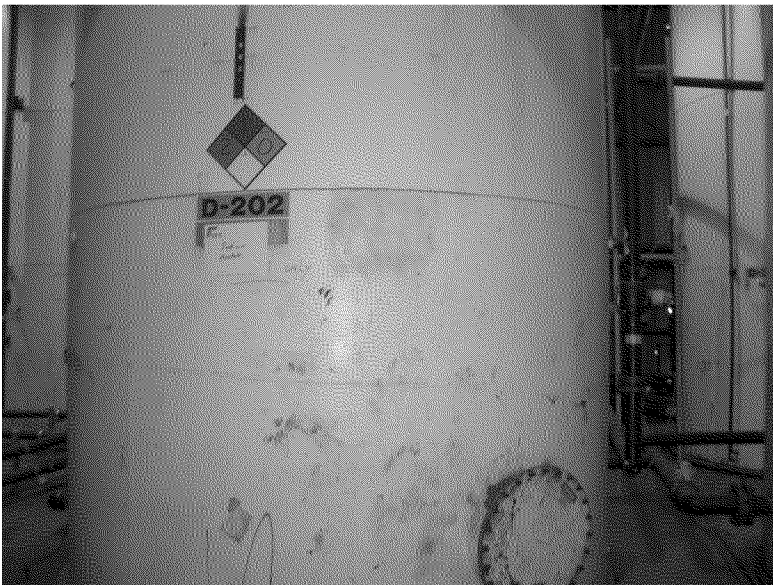
Photo# 26

Description: Tank No. D-202 labeled "Sodium Acetate" (IMGP0874)

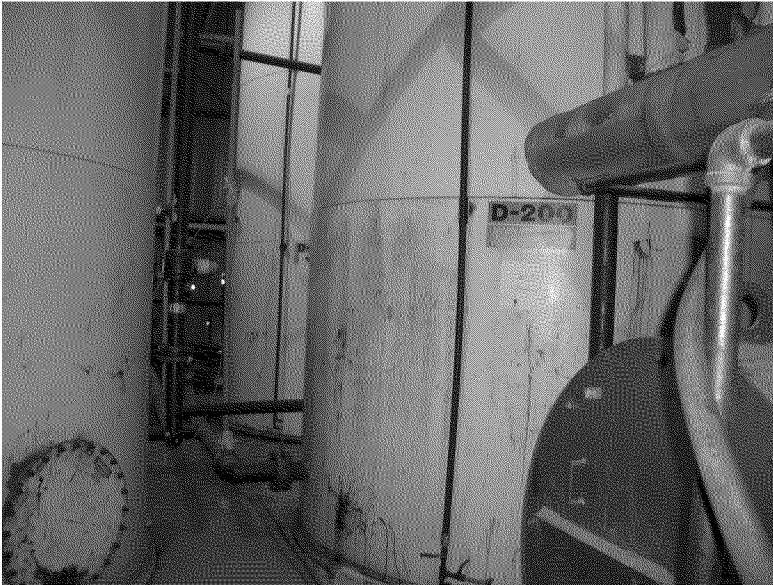
Photo# 27

Description: Tank No. D-200 labeled "Oil Emulsion" (IMGP0875)

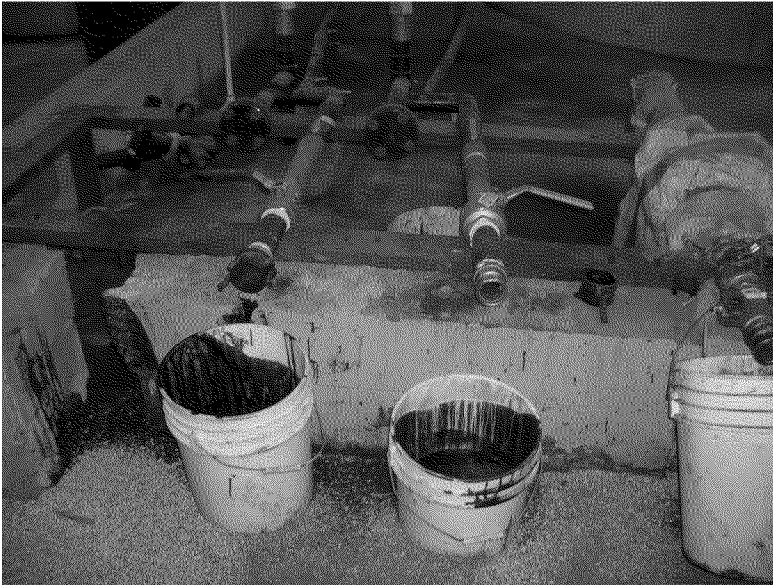
Photo# 29

Description: Drip buckets under piping (IMGP0877)

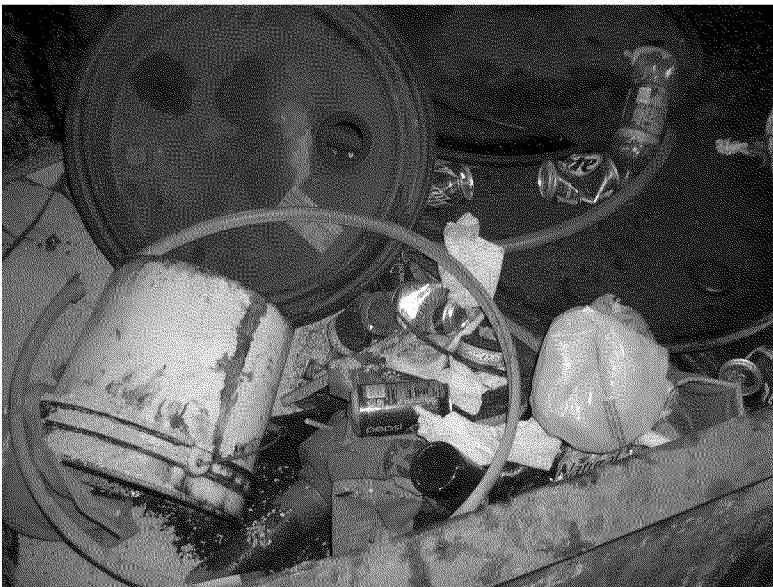
Photo# 30

Description: Dumpster with waste material including buckets and floor dry material (IMGP0878)

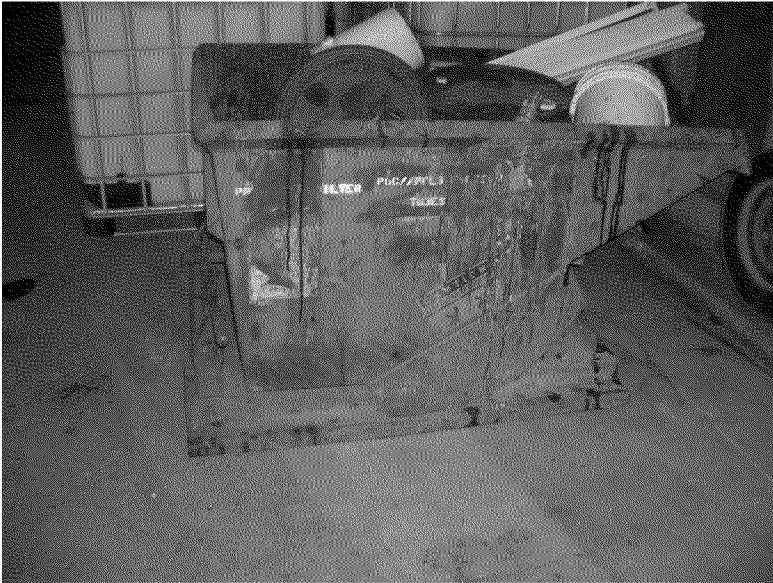
Photo# 31

Description: Dumpster with waste material (IMGP0879)

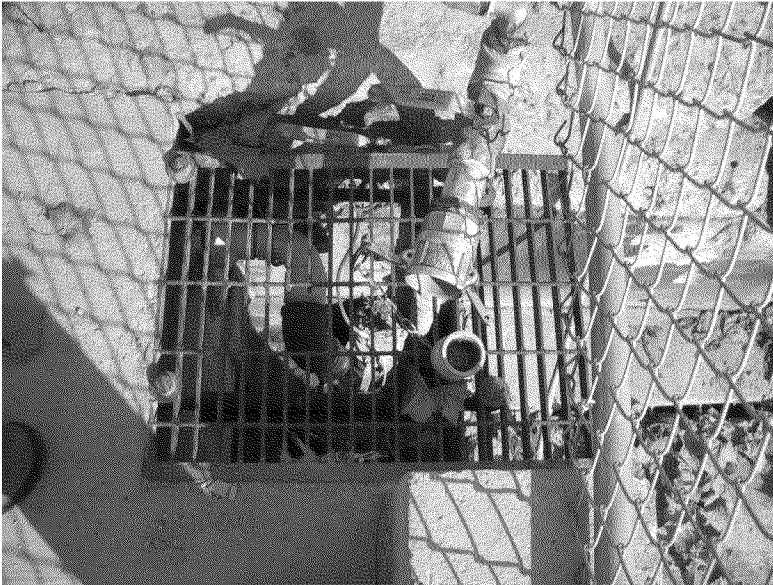
Photo# 33

Description: Piping/drain located outside at south end of the facility (IMGP0881)

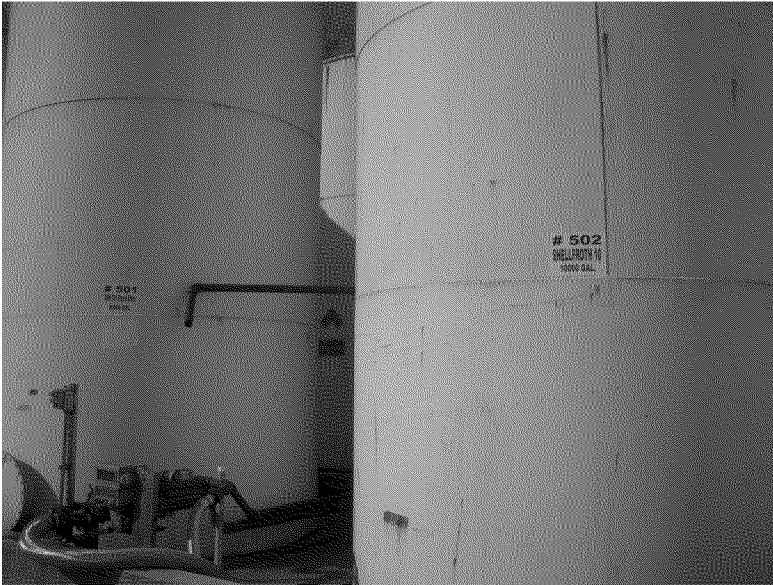
Photo# 37

Description: Storage tanks Nos. 501 and 502 located outside of building (IMGP0885)

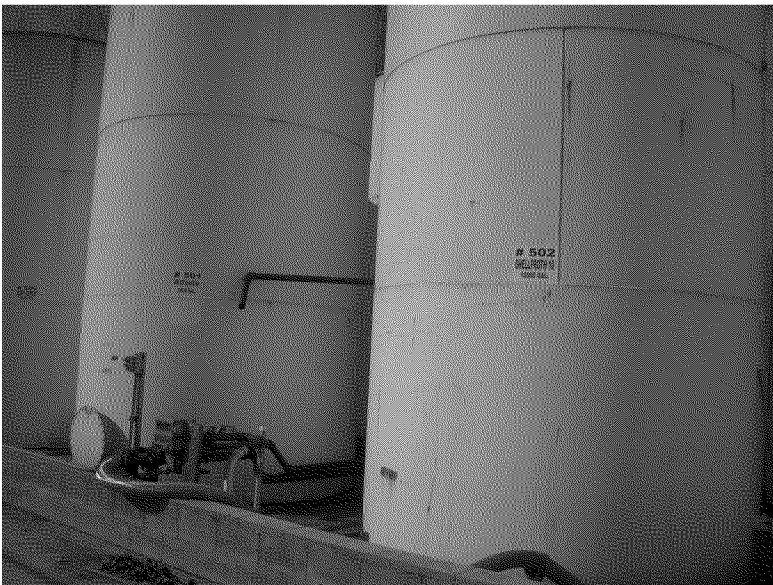
Photo# 38

Description: Storage tanks Nos. 500, 501 and 502 located outside of building (IMGP0886)

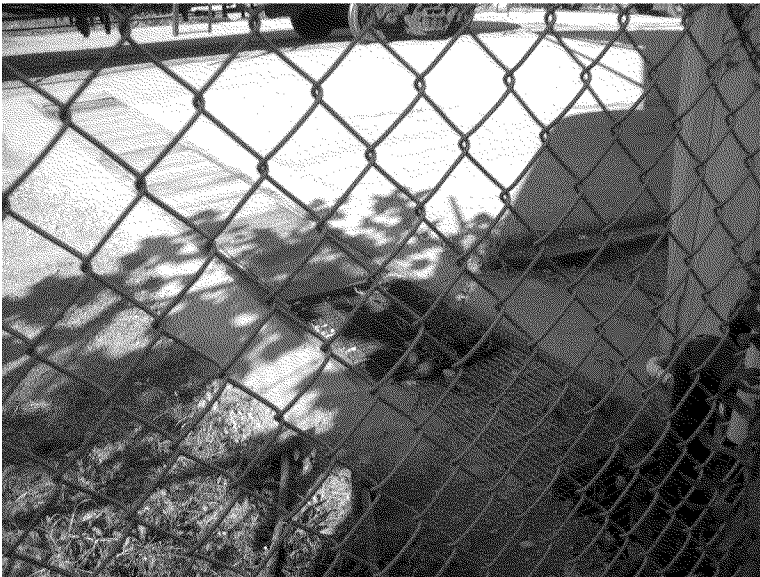
Photo# 40

Description: Trench at southwest corner of building (IMGP0888)
